Process for Assessing Proper Functioning Condition Erosion/Deposition Items

Erosion/Deposition Items

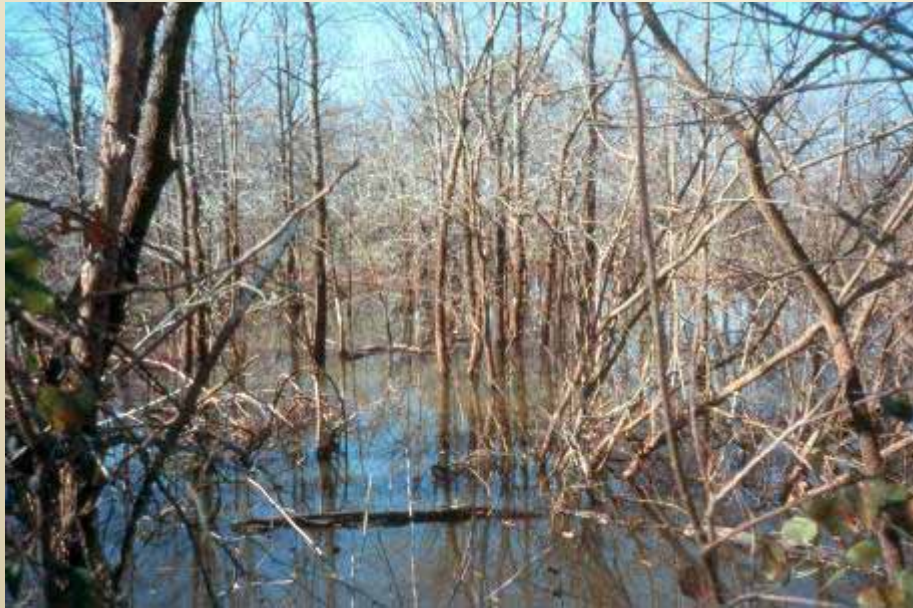
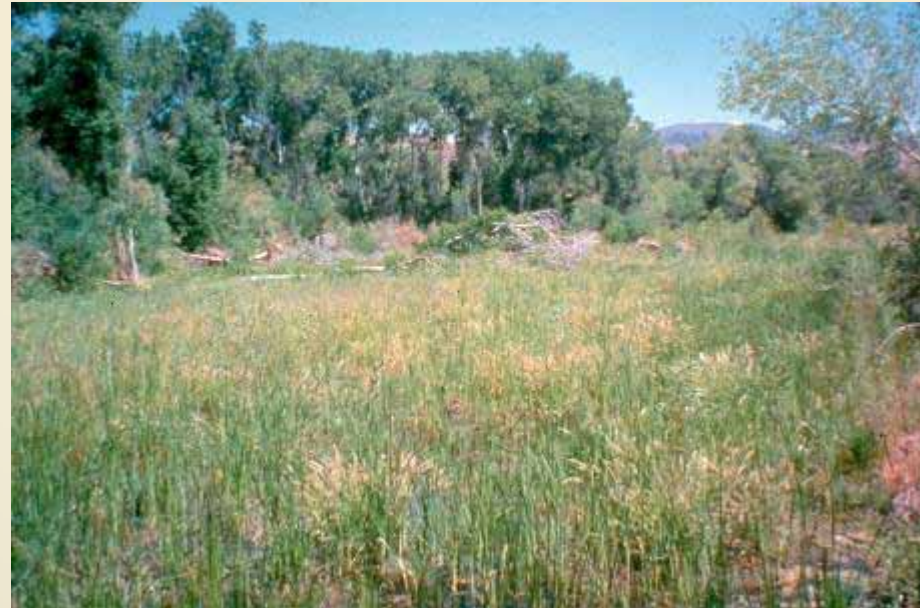
Santa Maria River, AZ

13) Floodplain and channel characteristics (i.e. rocks, overflow channels, coarse and/or large woody material) are adequate to dissipate energy

Visual indicators

Depending on streamtype - access to backwater areas, oxbows, overflow channels and their roughness elements

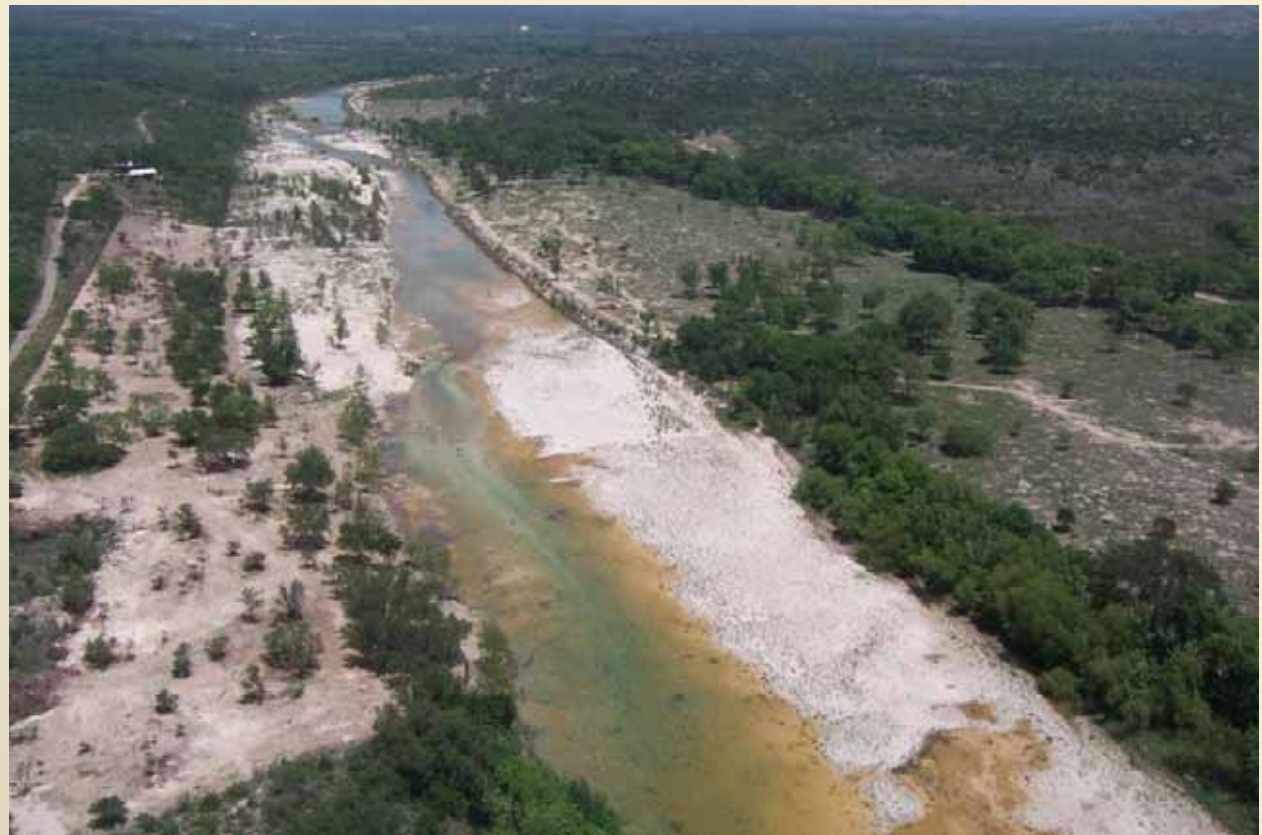
Nueces River, TX May 2009

13) Floodplain and channel characteristics (i.e. rocks, overflow channels, coarse and/or large woody material) are adequate to dissipate energy

Visual Indicators

Roughness - floodplain, bed, & bank

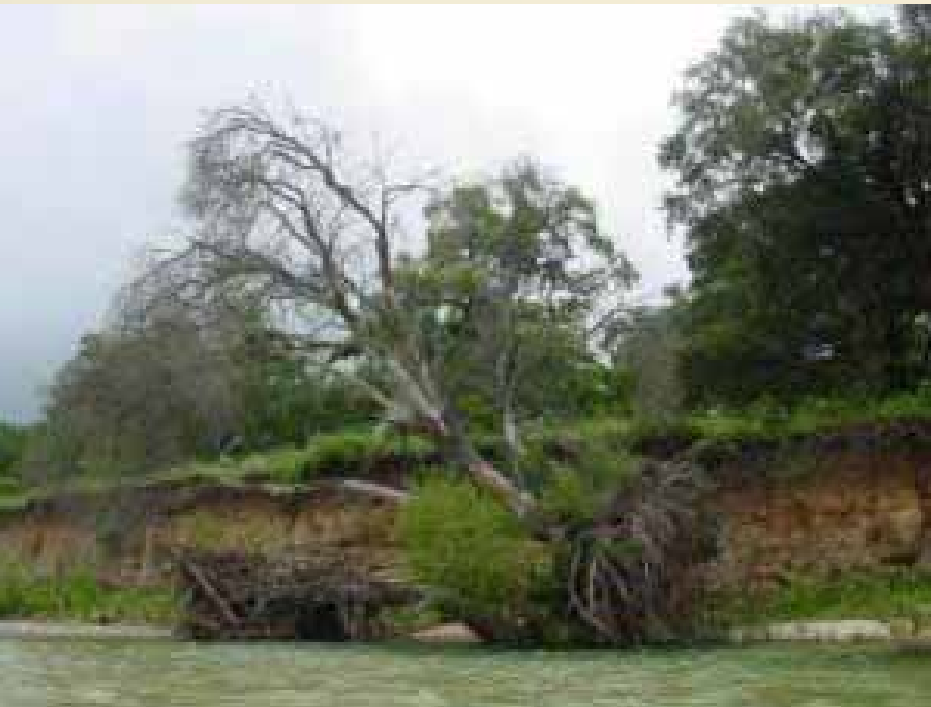
Nueces River, TX

13) Floodplain and channel characteristics (i.e. rocks, overflow channels, coarse and/or large woody material) are adequate to dissipate energy

Roughness - floodplain, bed, & bank

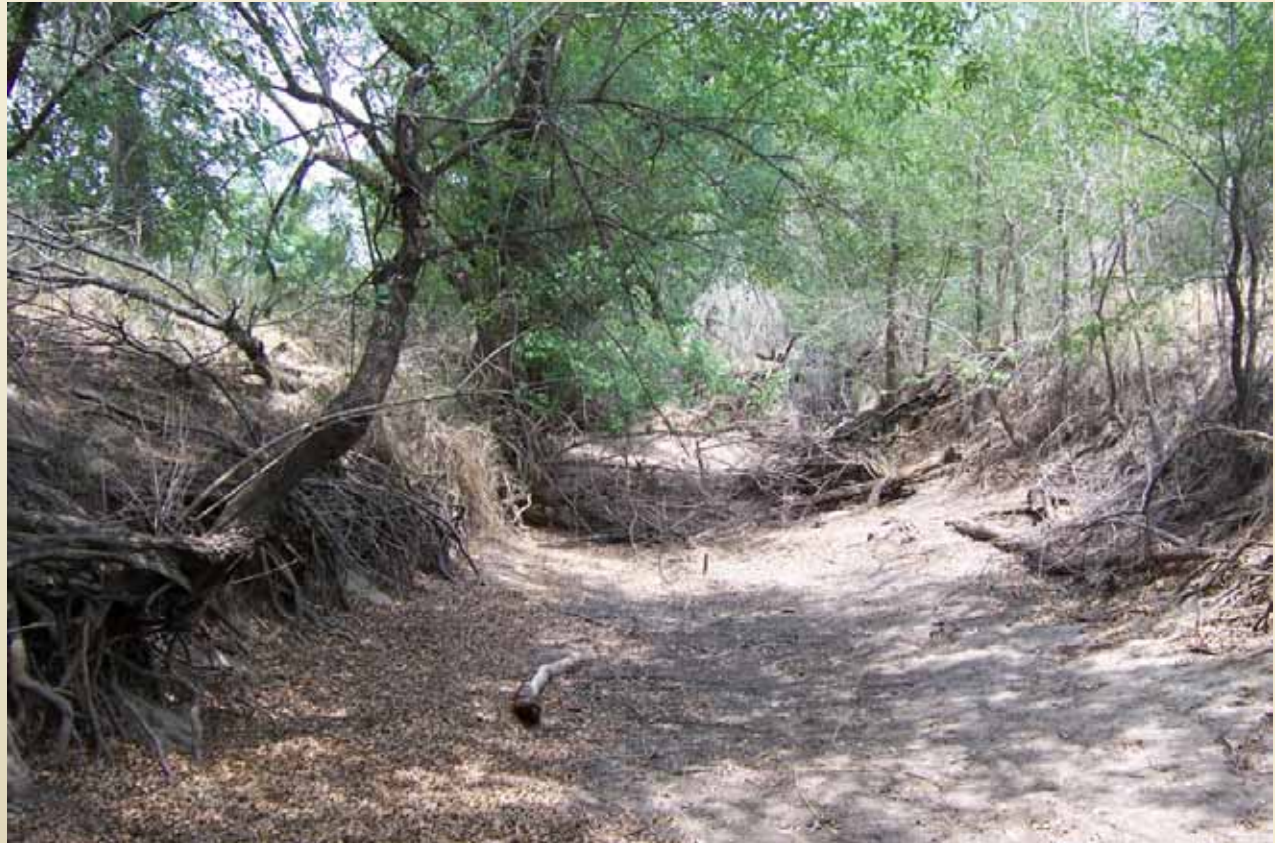
Picosa Creek, TX May 2009

13) Floodplain and channel characteristics (i.e. rocks, overflow channels, coarse and/or large woody material) are adequate to dissipate energy

Roughness - floodplain, bed, & bank

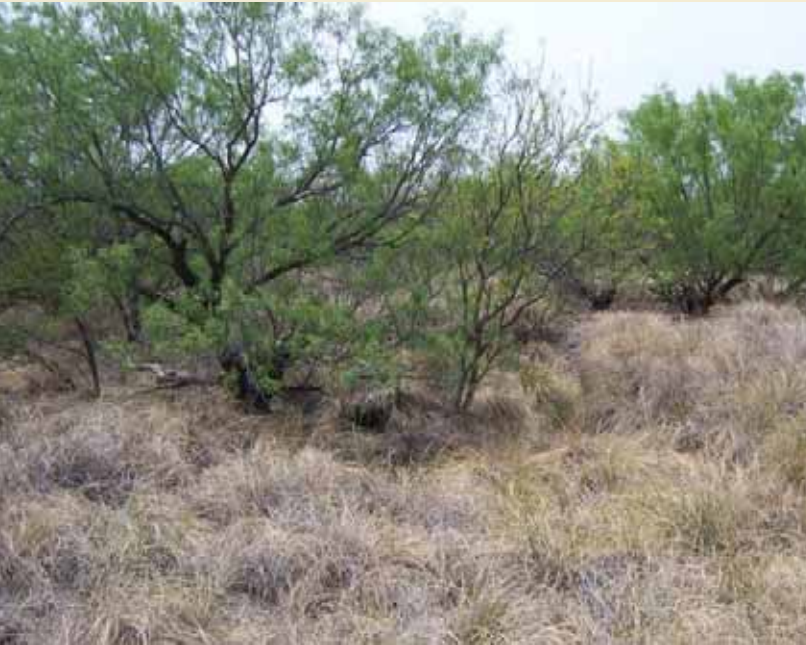
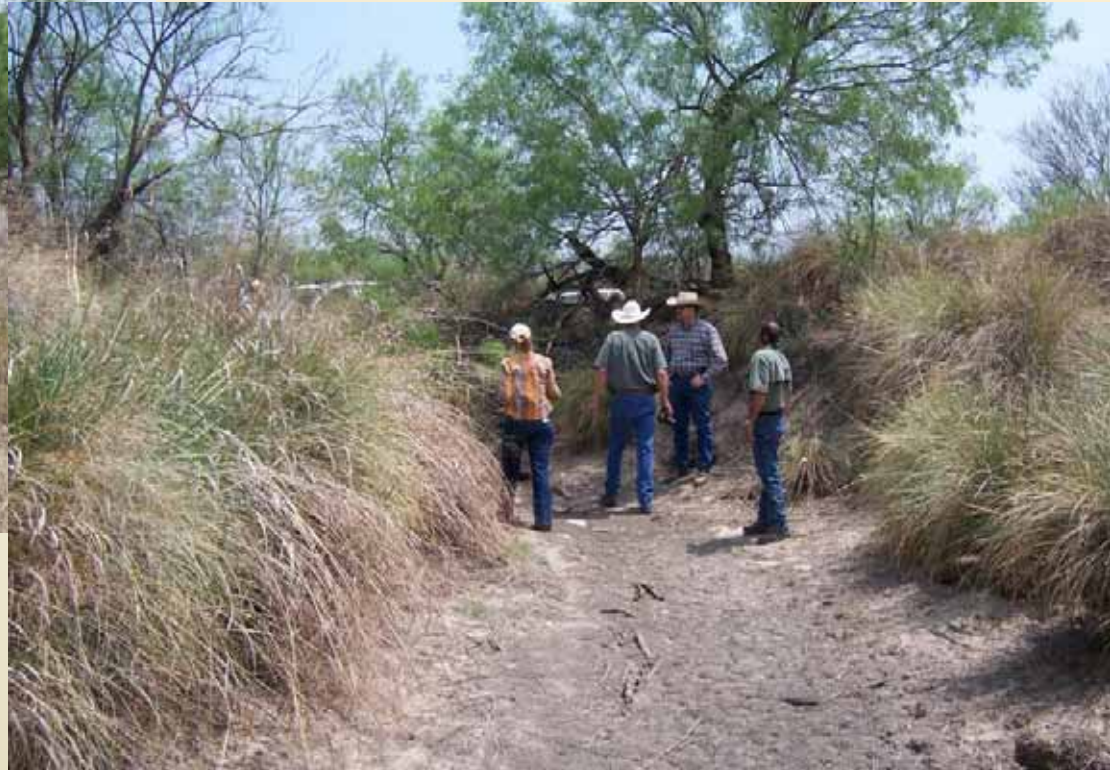
Tributary to Picoso Creek
Gulf cordgrass May 2009

13) Floodplain and channel characteristics (i.e. rocks, overflow channels, coarse and/or large woody material) are adequate to dissipate energy

Roughness - floodplain, bed, & bank

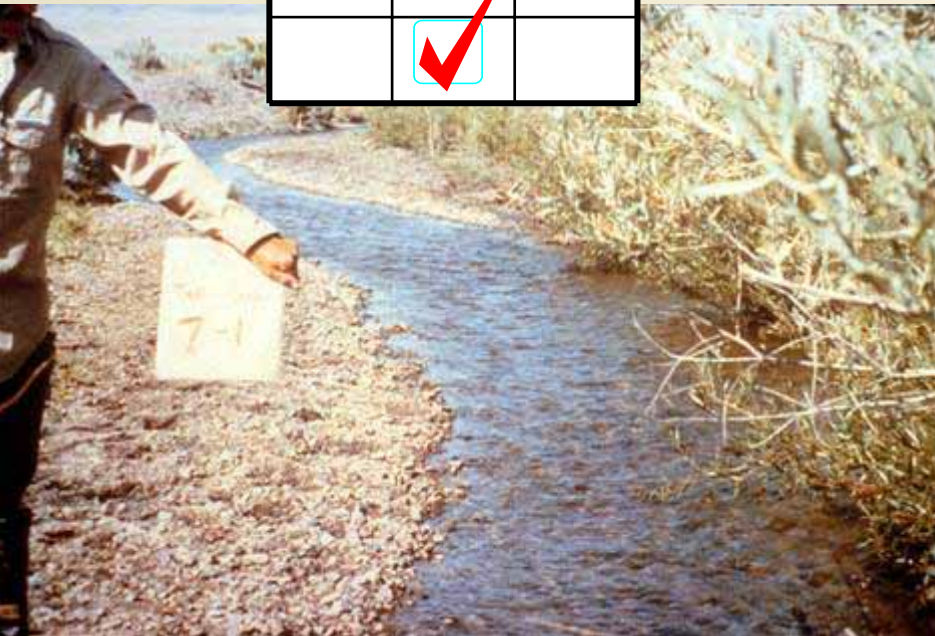
Tabor Creek, NV 1979

14) Point bars are revegetating with riparian-wetland vegetation

✓Vegetation is established and stabilizing point bars

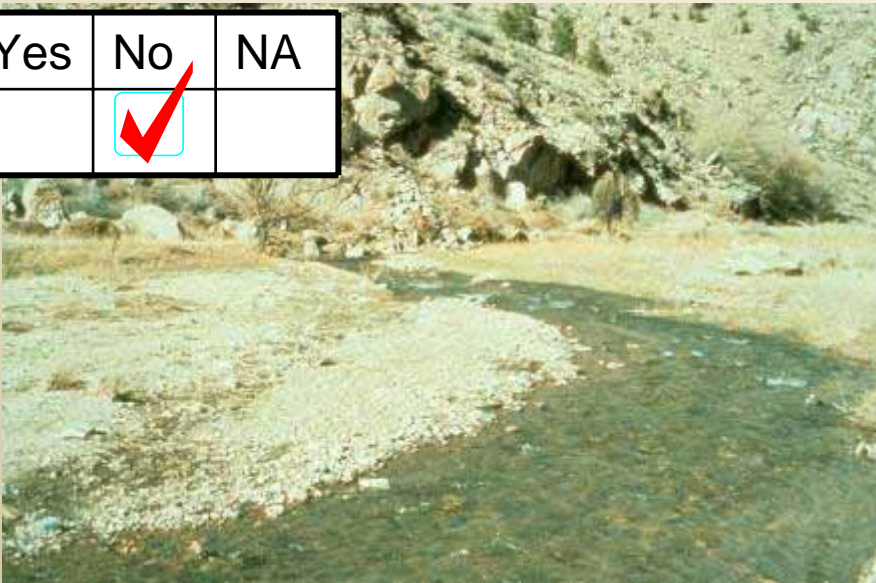
Texas Creek ,CO 1976

15) Lateral stream movement is associated with natural sinuosity

- How often channel relocates with moderate to high flow events
- Stable streambanks
- Natural deposition with very slow change in bed elevation

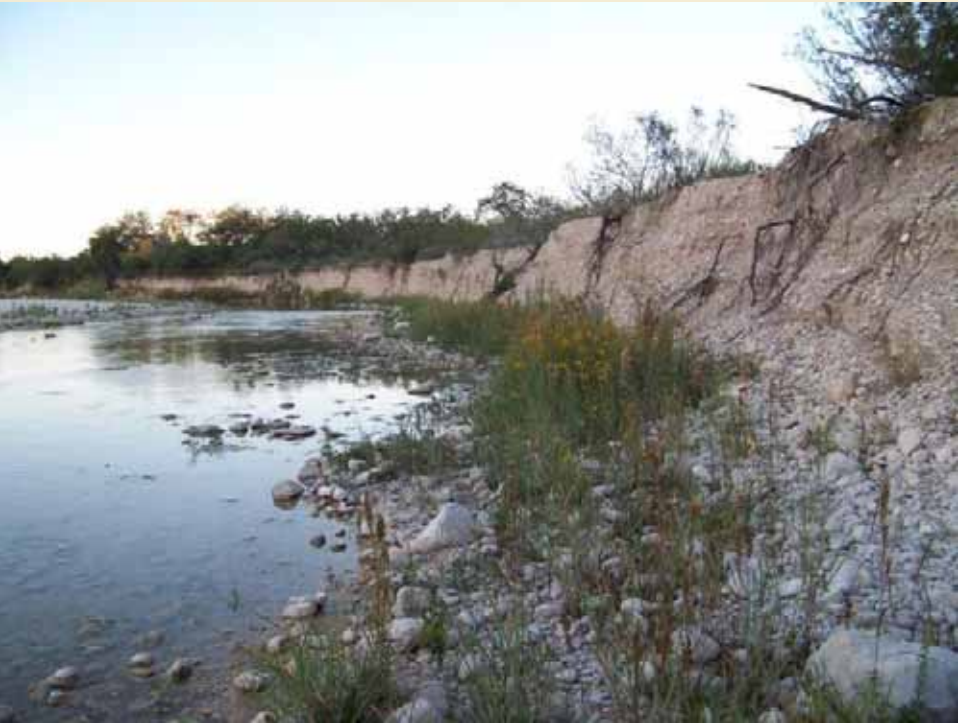
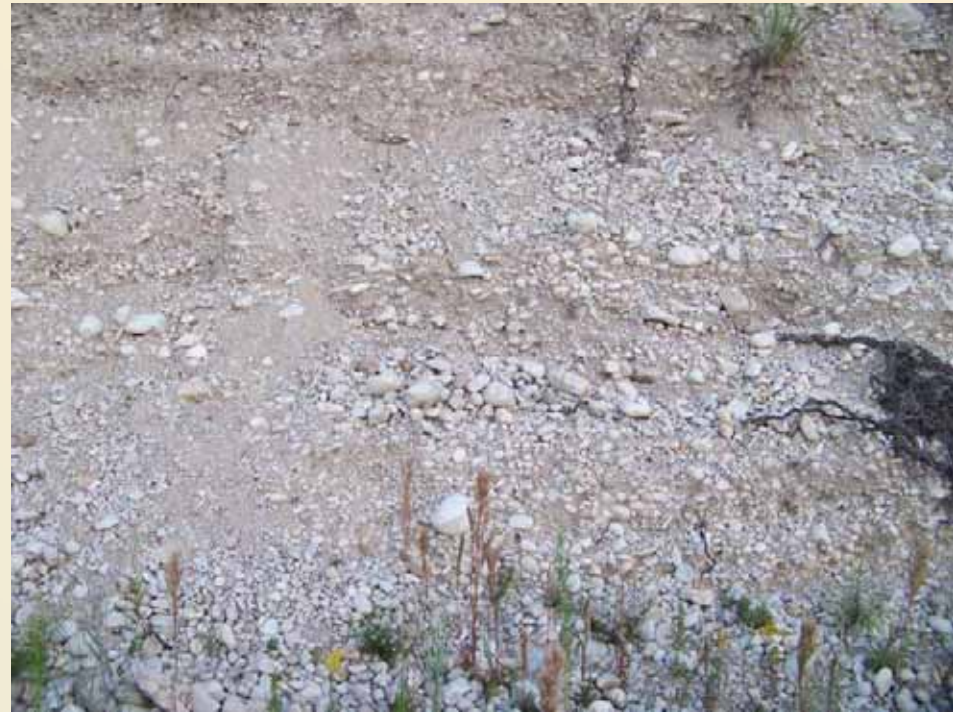
Nueces River, TX 2008

15) Lateral stream movement is associated with natural sinuosity

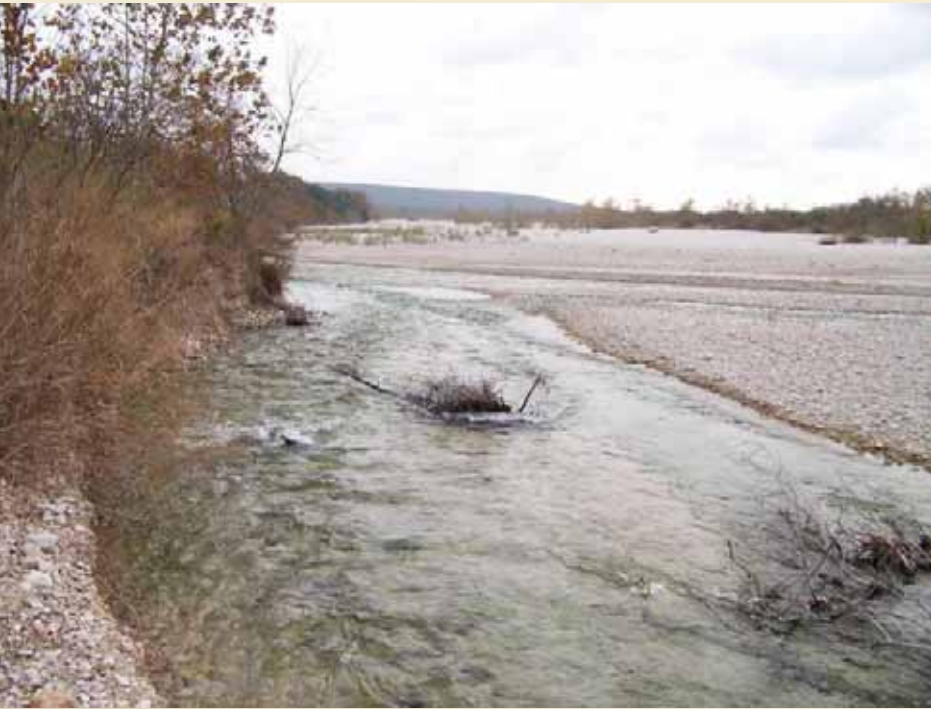
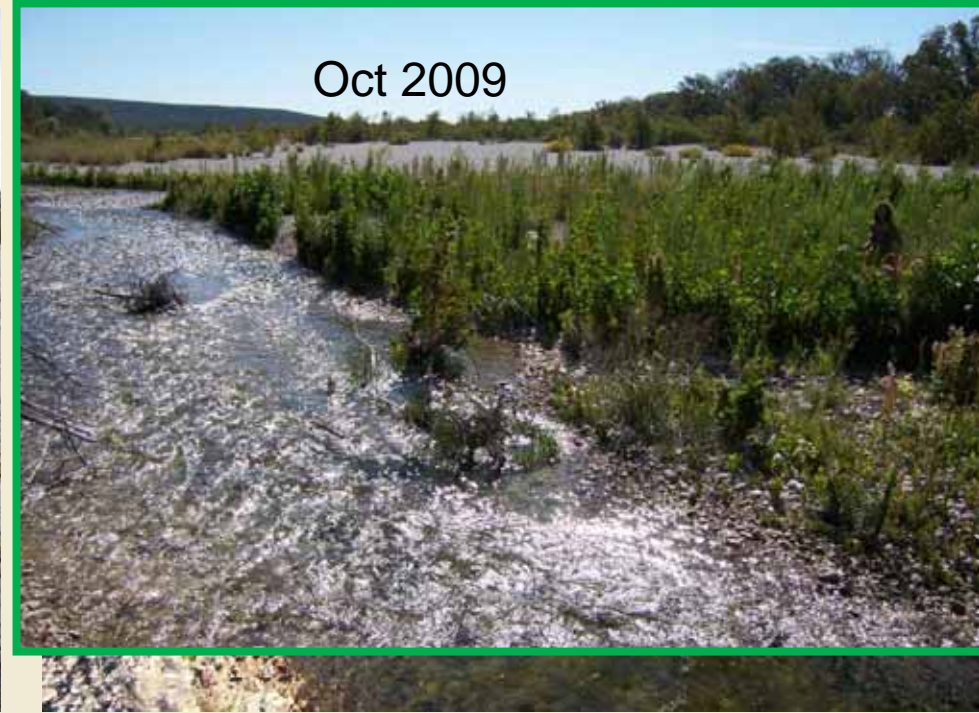
Nueces River, TX

15) Lateral stream movement is associated with natural sinuosity

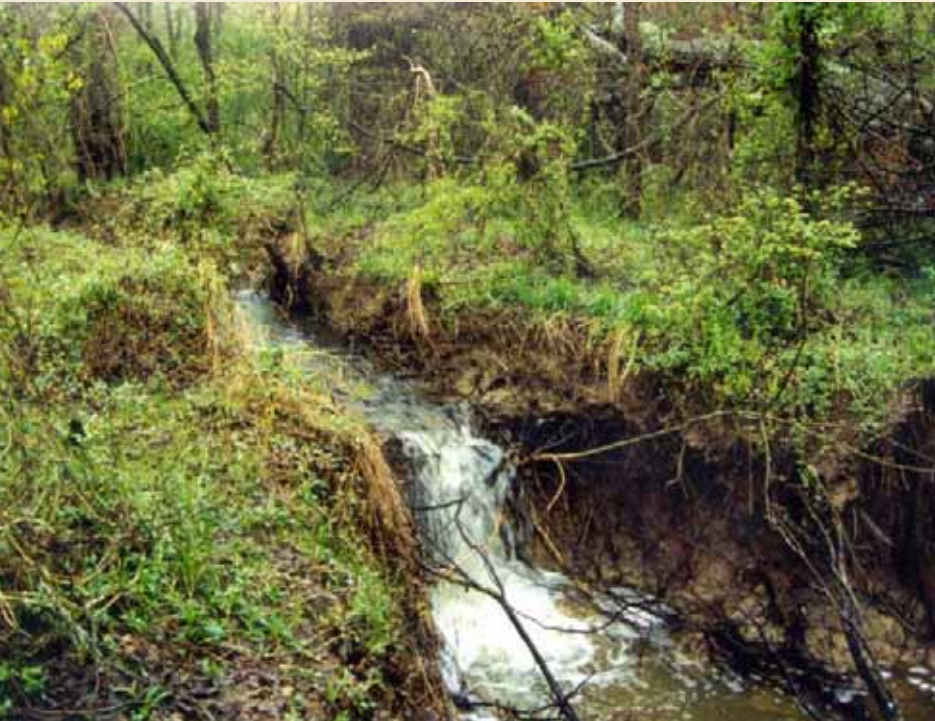
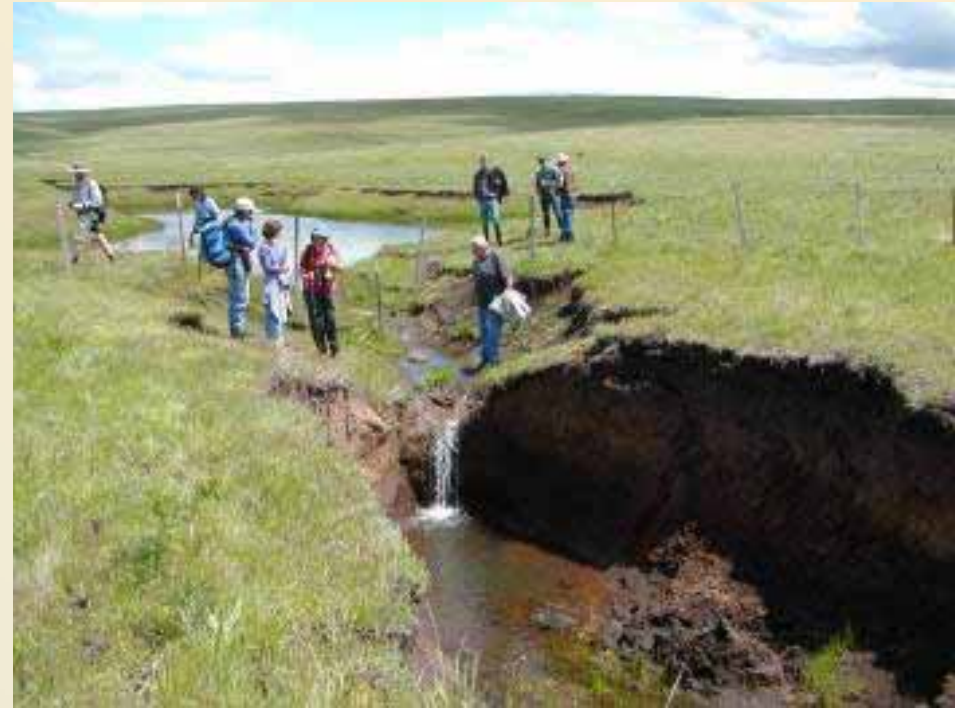
16) System is vertically stable

- Headcut(s) that lead to lowering of water table

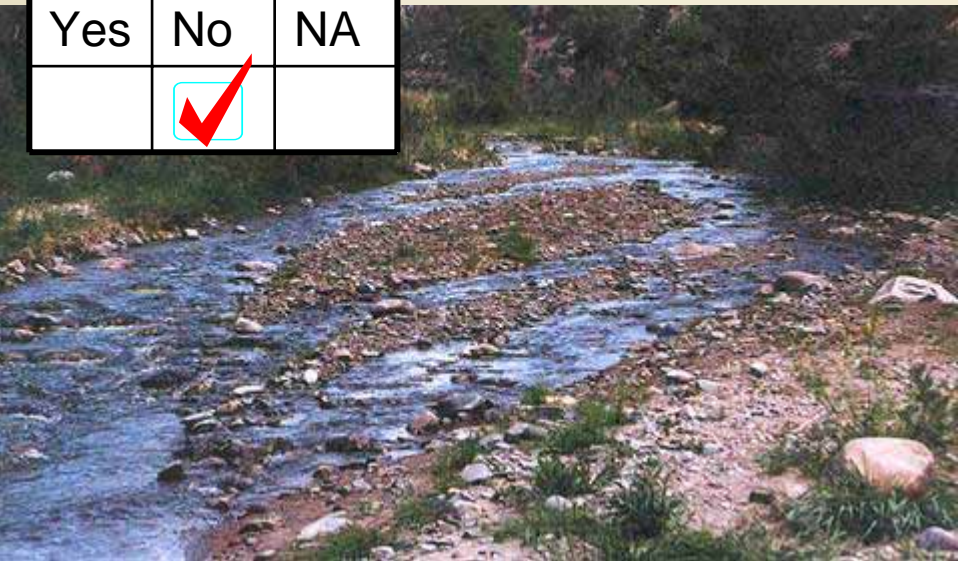
Badger Creek CO

17) Stream is in balance with the water and sediment being supplied by the watershed (i.e., no excessive erosion or deposition)

- Increase in mid-channel or cross-channel bars
- Bank erosion on either side of the channel in straight sections
- Bank erosion rates
- Flattening of pools (except in uniform sand channels with no potential for large woody material)

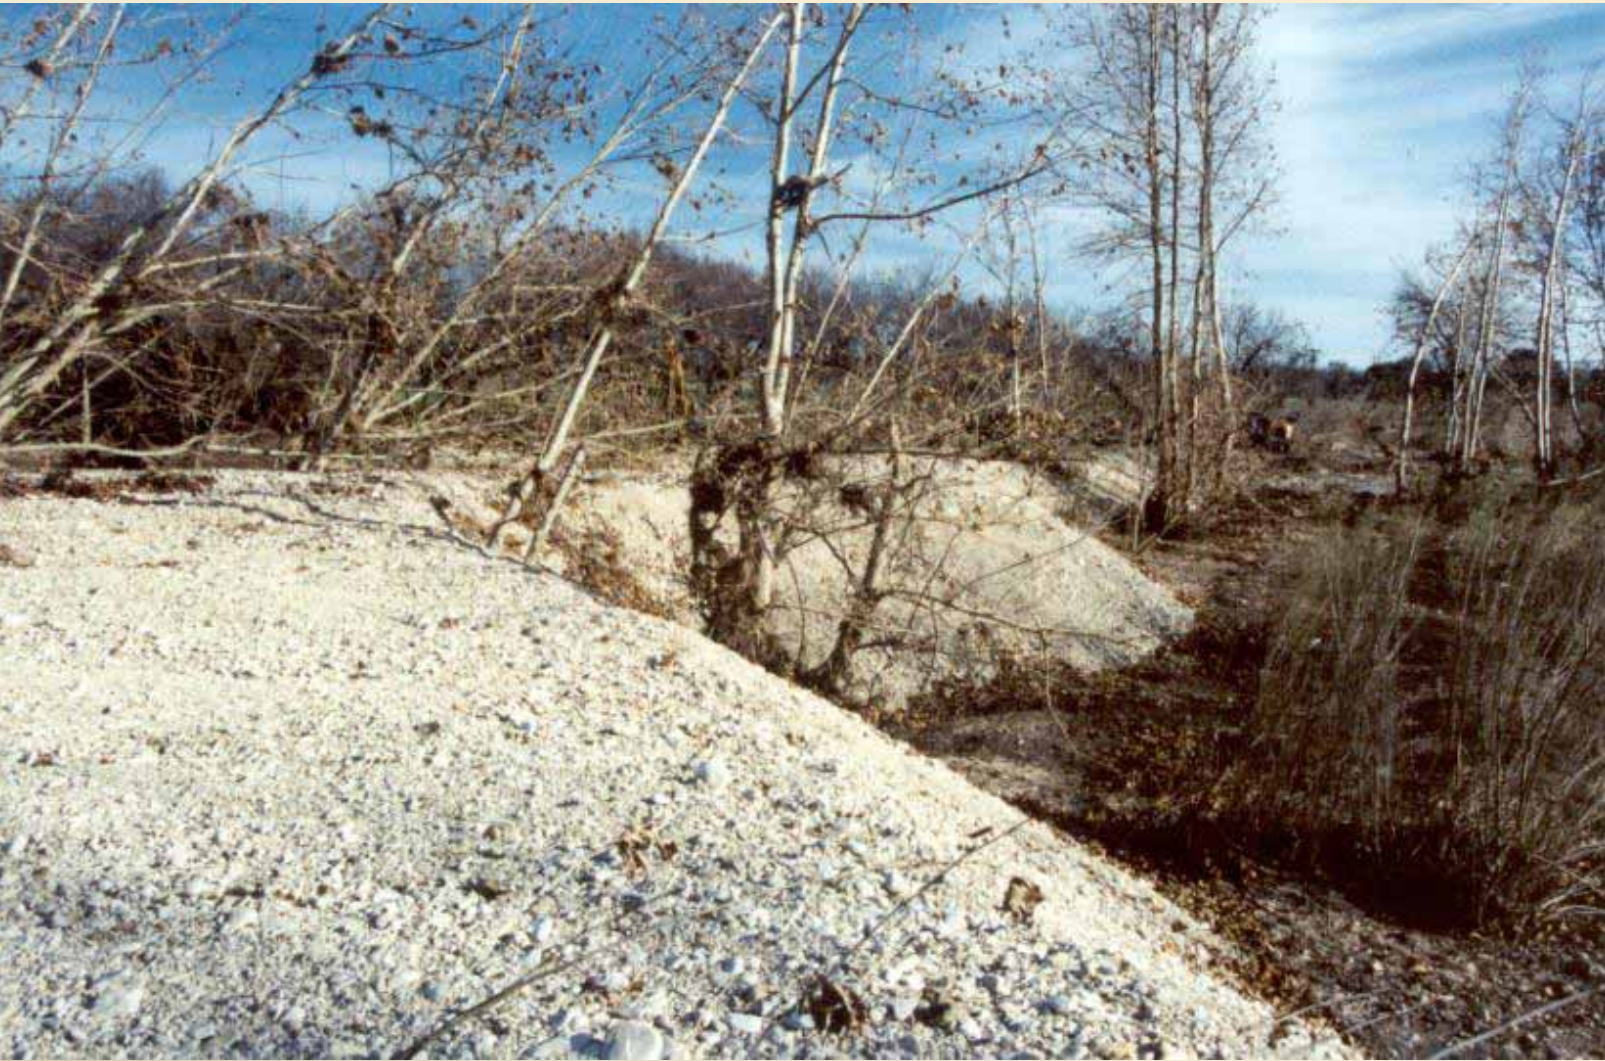
S Llano R, TX

17) Stream is in balance with the water and sediment being supplied by the watershed (i.e., no excessive erosion or deposition)

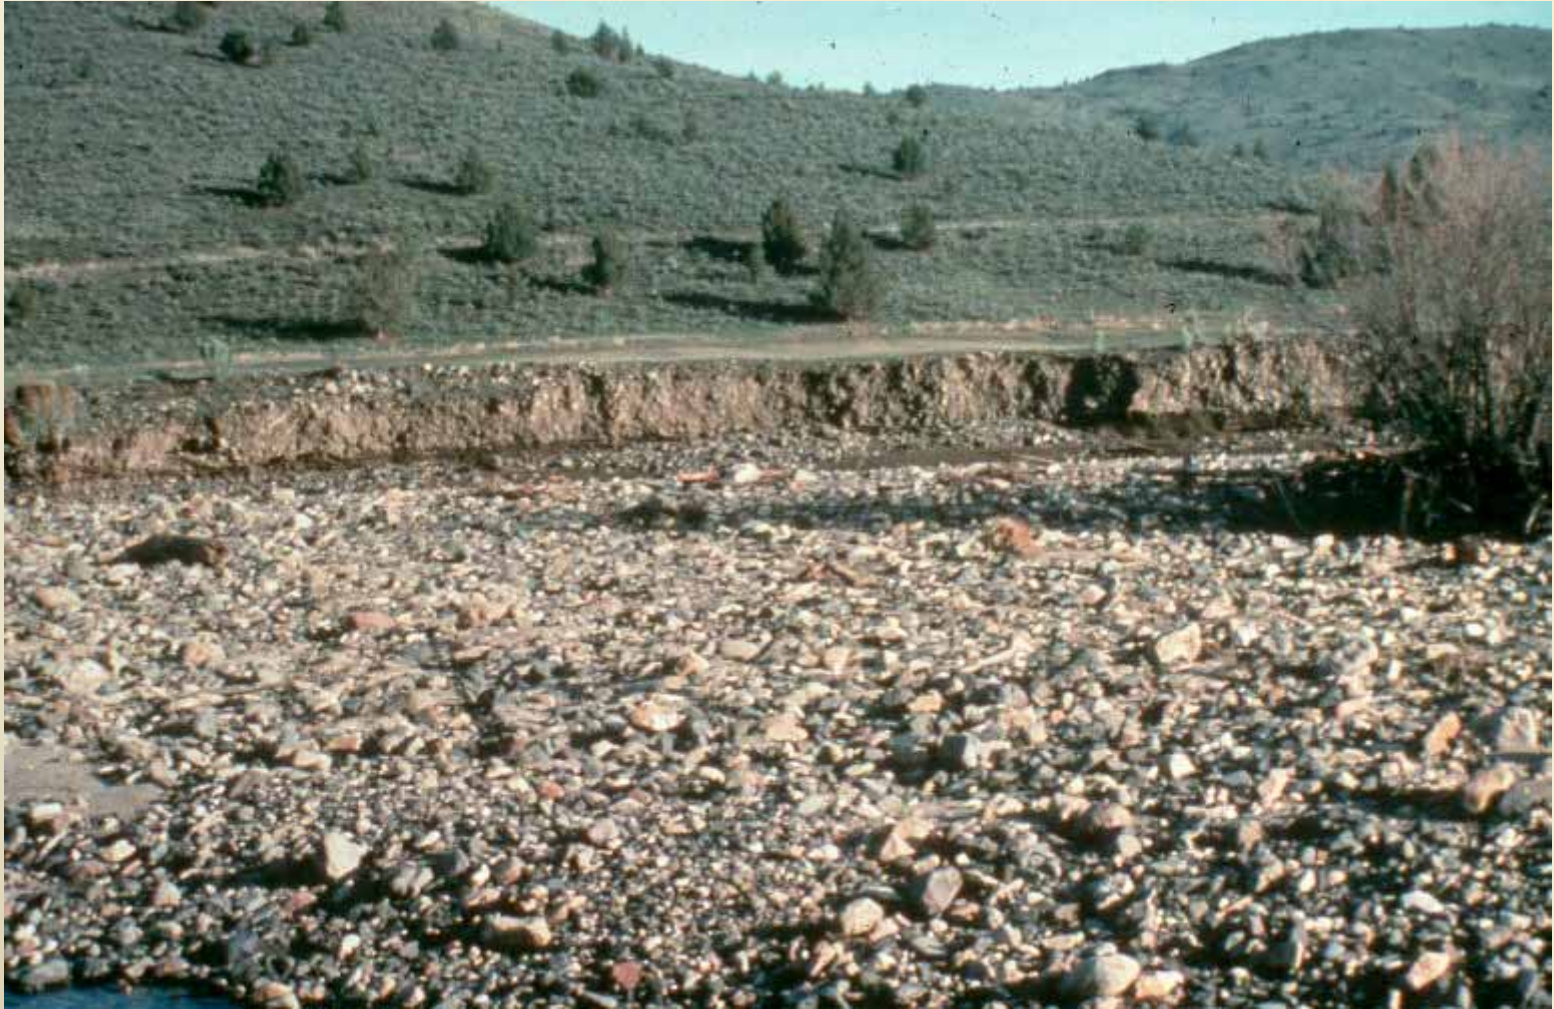
John Day R, OR

17) Stream is in balance with the water and sediment being supplied by the watershed (i.e., no excessive erosion or deposition)

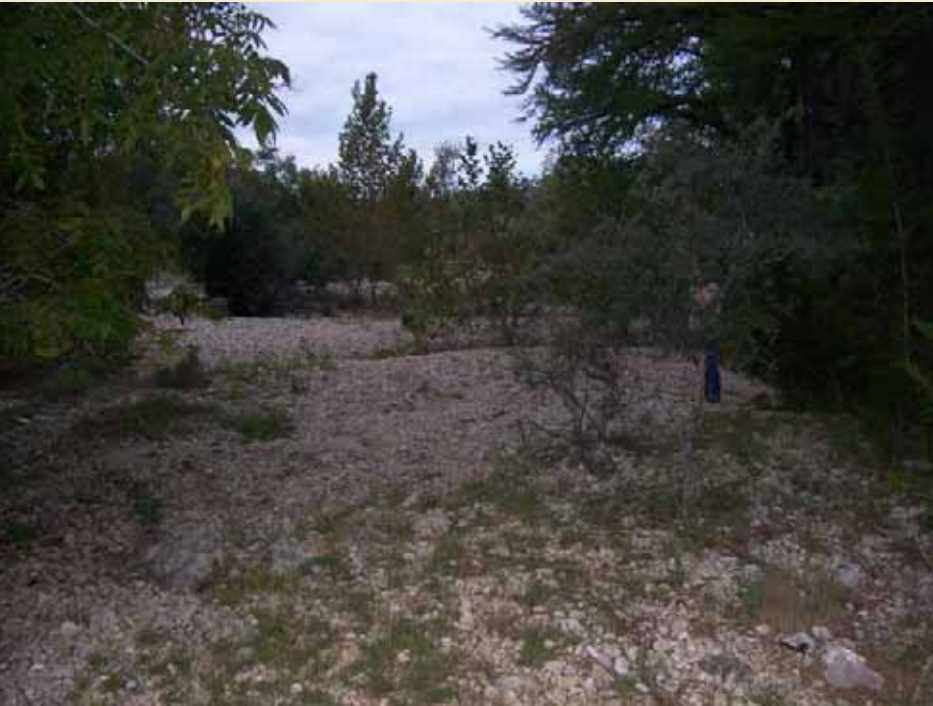
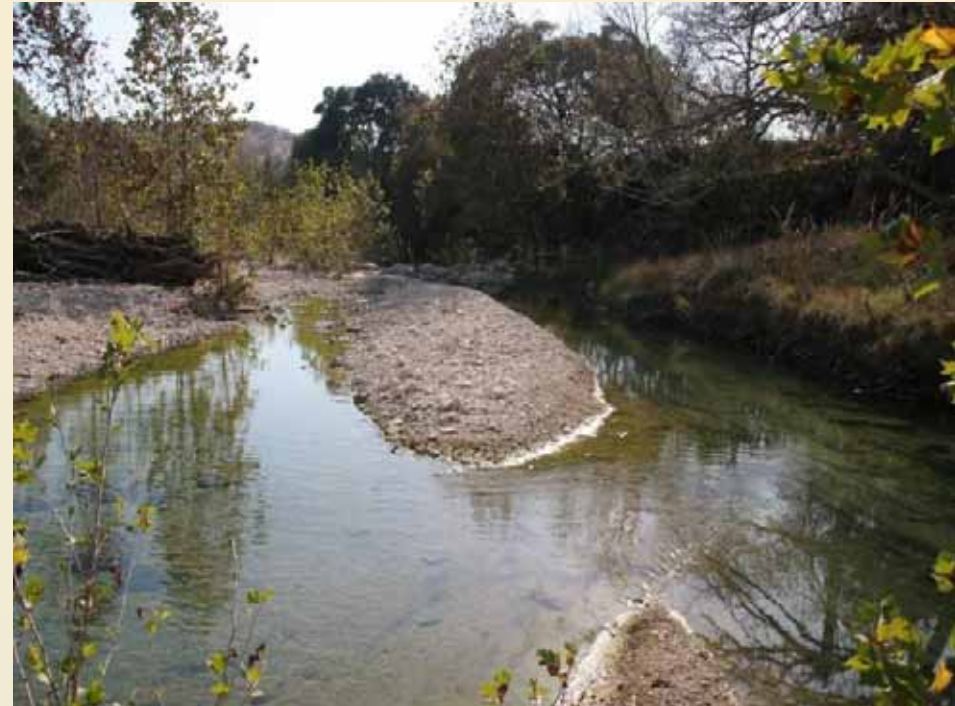
Near Kerrville TX

17) Stream is in balance with the water and sediment being supplied by the watershed (i.e., no excessive erosion or deposition)

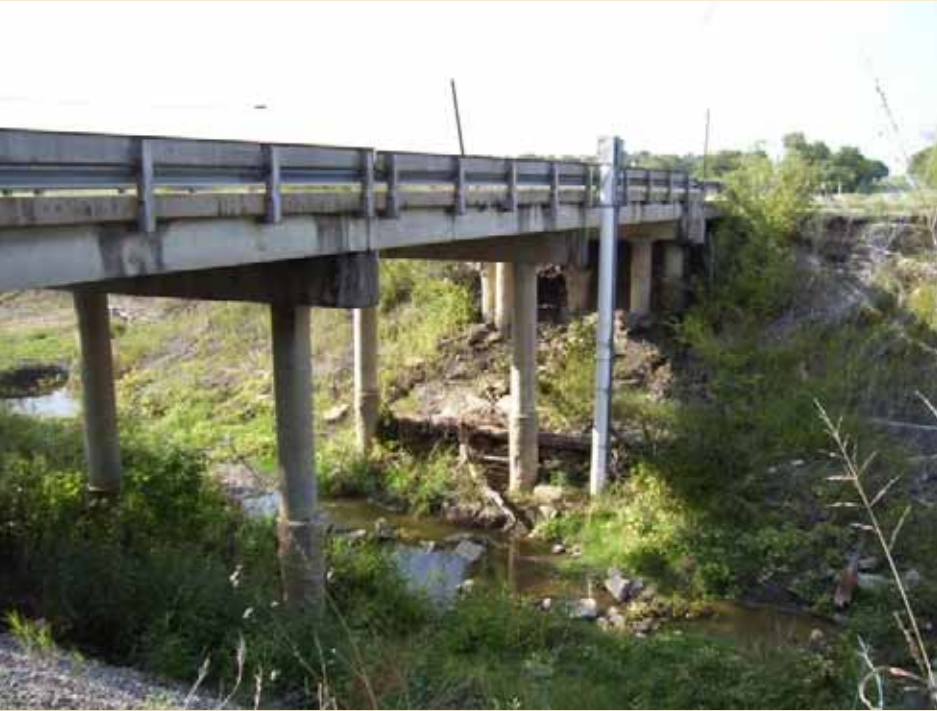
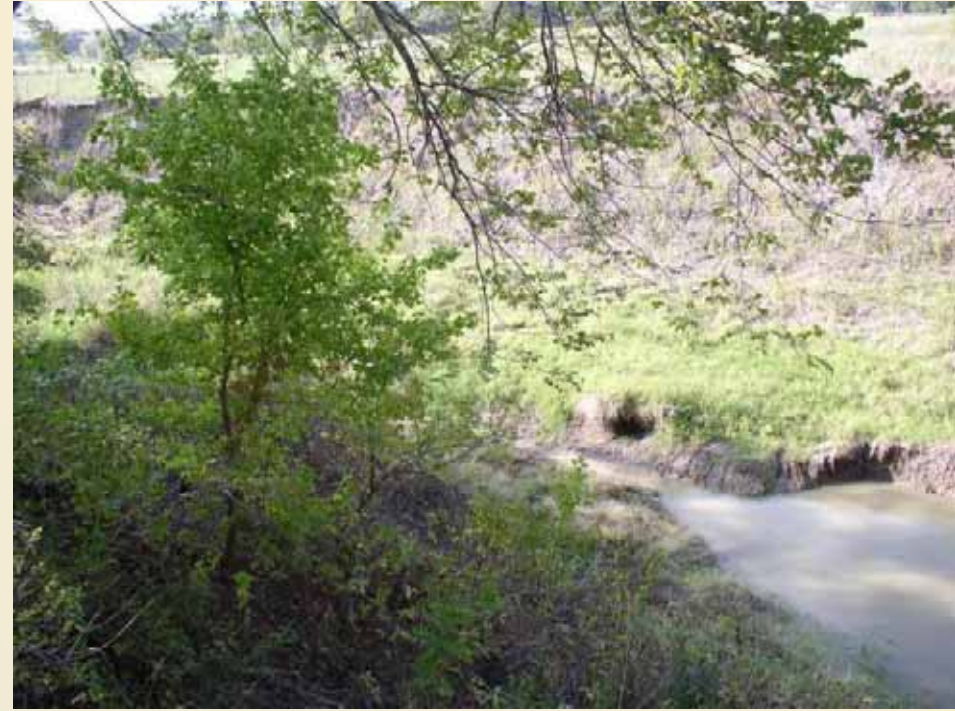
Near Corsicana TX

17) Stream is in balance with the water and sediment being supplied by the watershed (i.e., no excessive erosion or deposition)
